ALEXANDRIA

KOM EL-DIKKA PRESERVATION WORK 1996/97

Wojciech Kołataj

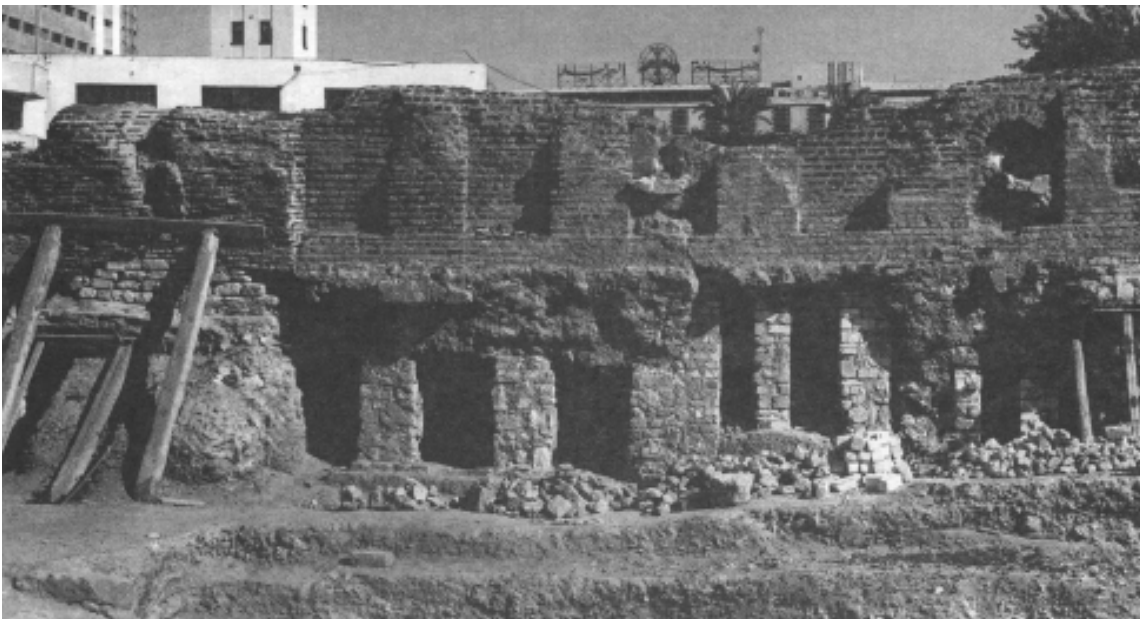
*Fig. 2. Northern facade of the cistern.
Photo W. Jerke.*

Clearing of the northern facade of the cistern in 1995/96 had revealed a dangerous overhanging of the upper parts of this elevation. Almost the entire length of this facade (c. 50 m²) was cleared this year, providing visible proof of the fact that practically the entire cistern complex stands on top of

a number of extensive voids created by the caving in of the structures that had lain underneath. The work was extremely dangerous, requiring the most endangered fragments to be cleared and protected on a step-by-step basis. Since protection in this case does not concern a historic building (cistern) and in any case it is only a structural reinforcement of fragments threatening to collapse, the supporting walls and pillars, of which a total of 17 m² was constructed, were made using a semi-cement mortar (fig. 2).

Investigations of the northern cistern facade proved that it had been robbed out in the Middle Ages in a section 20 m long and 2.50 m or more high. The reconstruction of this wall facing will be completed next year.

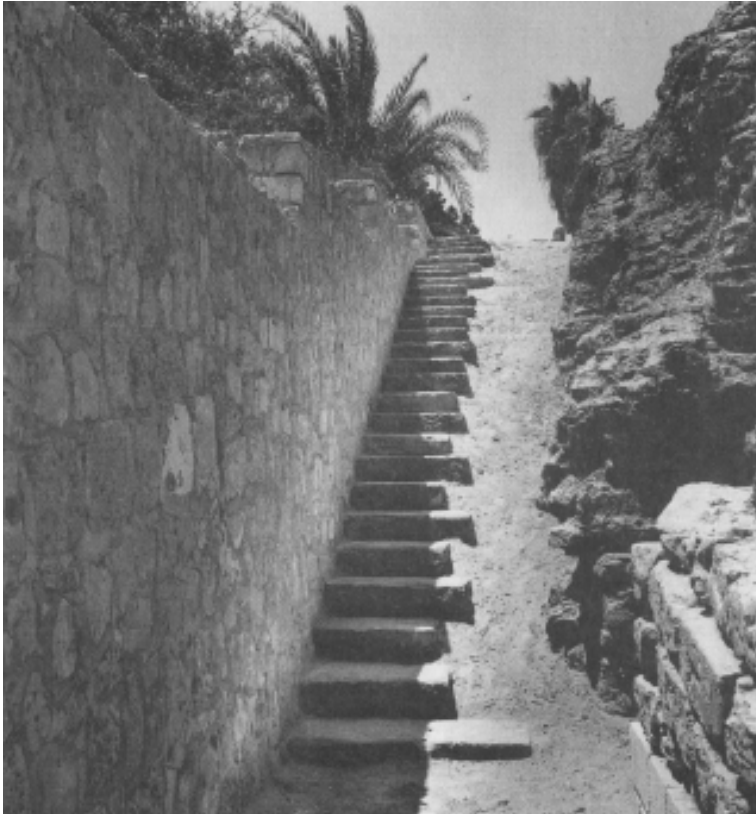
*Fig. 3. New stairs and revetment wall at the southern edge of the cistern.
Photo W. Jerke.*

With respect to the *Zona Monumentale* landscaping project, it should be noted that 2,000 m³ of excavated soil were removed from the area of the bath's *frigidarium*, as well as modern deposits from the surface layers in the area between the theater and the bath complex. Besides, a total of 25 m of pavement and steps was laid along the southern perimeter of the site, using basalt slabs and basalt and granite cobblestones recovered from the debris accumulated in the modern layers (fig. 3).
