POLISH-EGYPTIAN RESTORATION MISSION AT KOM EL-DIKKA, ALEXANDRIA, 1992-93

Wojciech Kołątaj

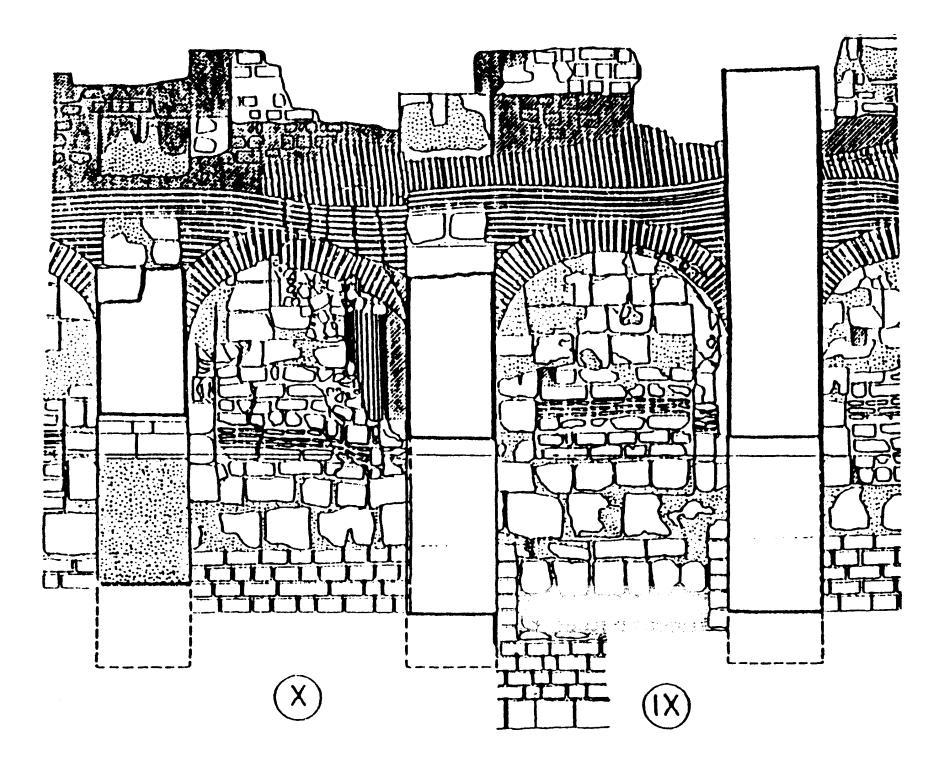
Following the consolidation of the unit X arcade in the theater corridor, that is, ambulacrum, the central segment was explored, removing the fill deposited after the edifice had been abandoned in the 7th century. The adjacent section of the outer wall, which also sustained heavy damage during modern construction works in 1964 before the theater was discovered, also called for immediate consolidation (Fig. 1). An inventory was made of the wall facing before the entire section was dismantled; the wall was then reassembled preserving as much of the ancient substance as could be retrieved; in many cases the original mortar in the joints was preserved, although several seriously damaged or crushed blocks had to be replaced with new ones (Fig. 2). The newly applied mortar was similar to the ancient one and composed of sand, lime, and powdered bricks with a 5% addition of white Portland cement. In the upper part of the wall, a com-

Fig. 1. Theater. Inner face of the corridor prior to restoration. Drawing by the author.

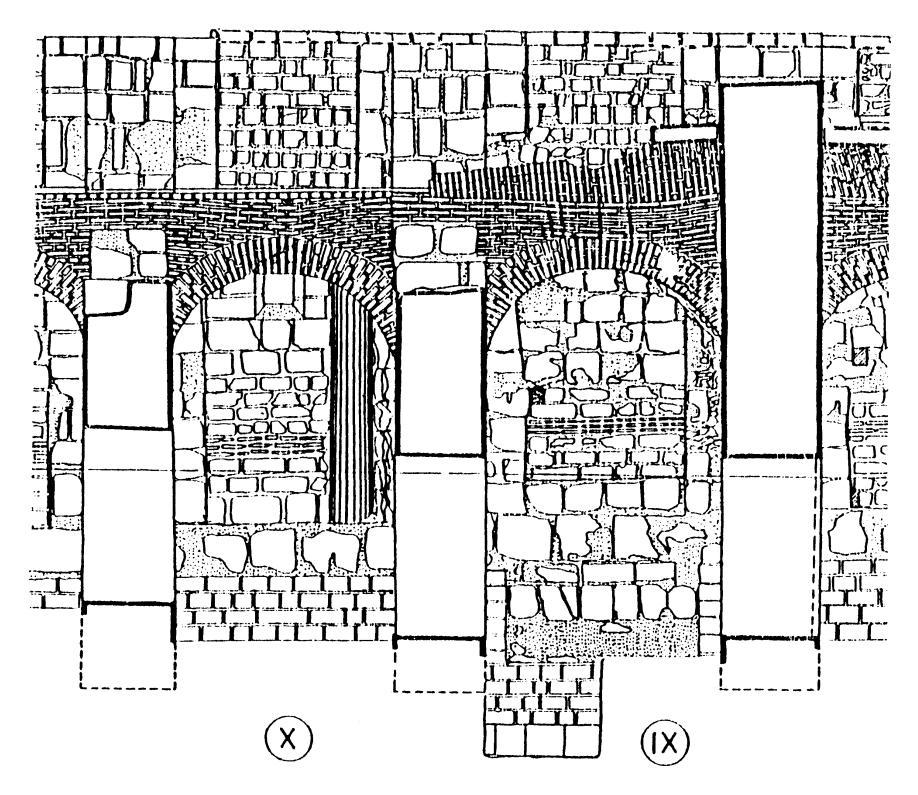
Fig. 2. Theater. Inner face of the corridor after restoration. Drawing by the author.

pletely destroyed window frame was thoroughly restored to its original shape.

A modern concrete pillar set into the wall was left in place for structural reasons as much as educational purposes

(removing the pillar could have caused serious damage to the wall, while it has already become part of the monument's history). The described restorations have made archaeological explorations possible well below the floor level of the corridor. In their course, the edifice's very deep foundations were uncovered, permitting archaeological and architectural studies to be completed.
